Location	Texas A&M University
Project Type	Test Program for Rehabilitation of Deteriorated Timber Piles Using the SeaShield Series 400 System
SeaShield™ Series 400 System Includes	SeaShield Fiber Form Jackets, SeaShield 510 UW Grout and C-GRID® 450 Carbon Fiber Grid

# SeaShield Series 400

Structural repair system that doubles the strength of the original timber pile

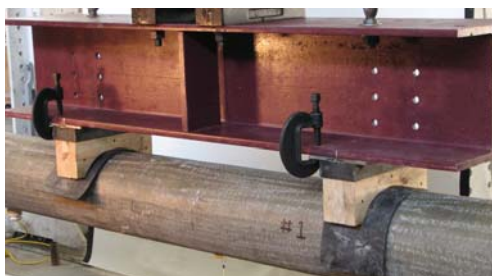
Bending test setup & actuator for the SeaShield Series 400.

**Test Setup:** Six each 8" diameter x 16' long timber piles were tested in bending using a four point bending setup. To simulate deterioration, five of the piles had an hourglass-shaped cut into them at mid-span. One specimen was left undamaged which was used as a baseline control specimen.

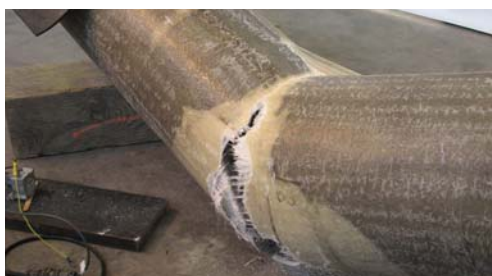
Completed bending test – all piles doubled in strength compared to the original unprotected piles.

**Results:** The results of the six pile bending tests proved that all repaired piles exceeded the bending strength of the baseline pile by at least double the maximum load achieved by the baseline pile.

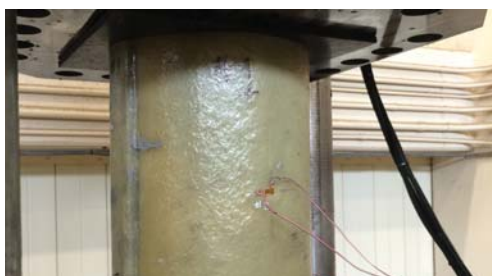
Compressive test setup.

**Test Setup:** Four each 8" diameter x 20" long timber piles with a fiberglass reinforced jackets, grout and carbon fiber grid. One specimen was a plain timber pile with no repairs and used as a baseline control pile. The objective was to evaluate the behavior of the repairs and quantify the additional compressive strength from the repairs vs. the baseline control specimen.
